WEEK NUMBER ROLLOVER - FIRMWARE UPDATE

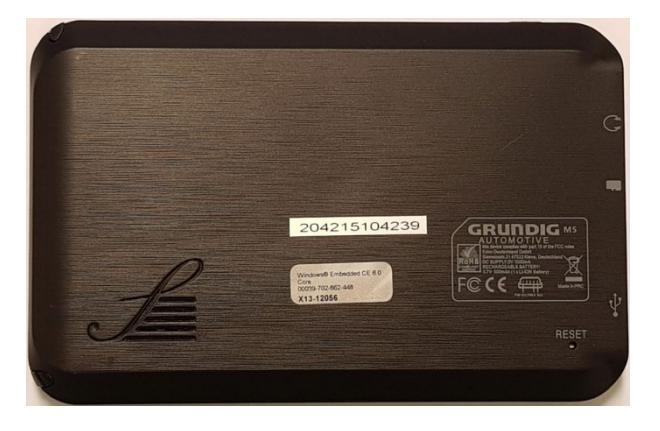
A firmware update is only suitable for this model:

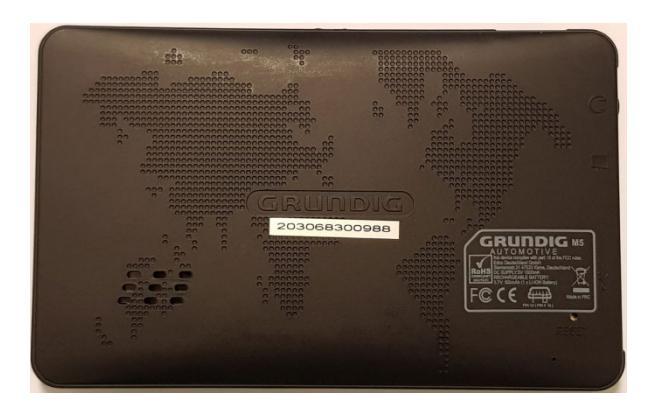
A firmware update is NOT suitable for the following model:
